# Fluid & Air Transfer - TIME Ball Valve

## TIME SG Iron Ball Valves

Hydrostatic Pressure Test of Ball Valves  
for TIME Limited

Page 2 of 3  
Report No. 13-06-C0161

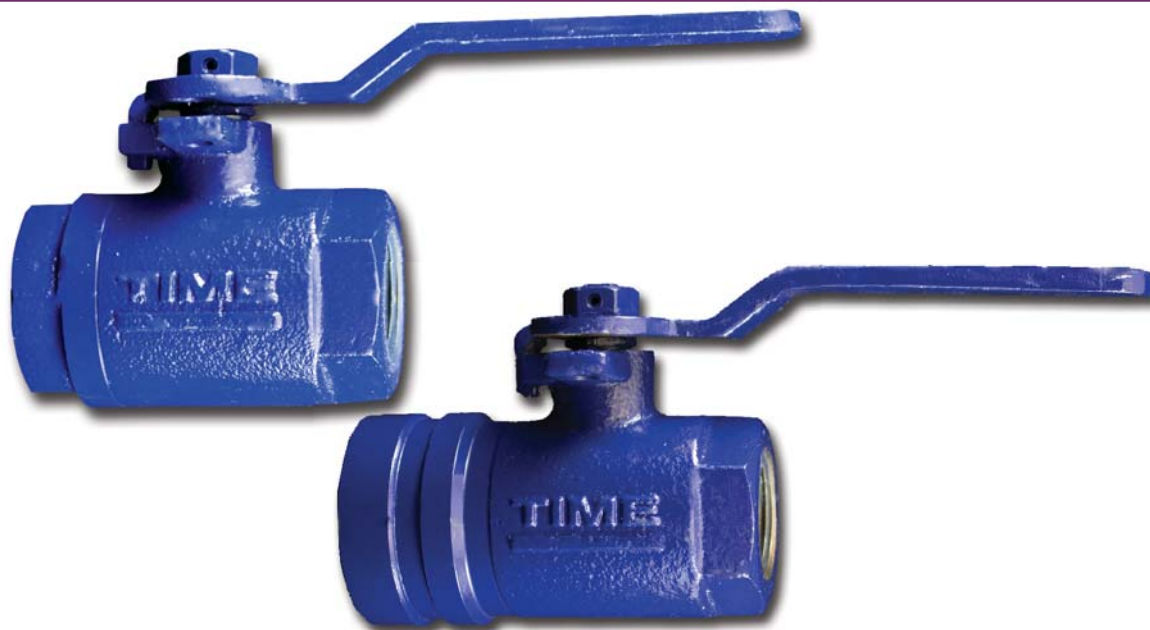
***Manufactured for use in a rugged, underground, mine environment.***

- Rugged SG Iron Cast body
- Ground full flow Stainless Steel Floating Ball
- NPT Threads
- Stainless Steel Spindle & Thrust washer & nut.
- PTFE Spindle Seals & Ball Seats
- 90 degree quarter turn Lever Handle
- Designed with a lockable handle in both the on and off positions
- Sizes range from 1/2" up to 2"

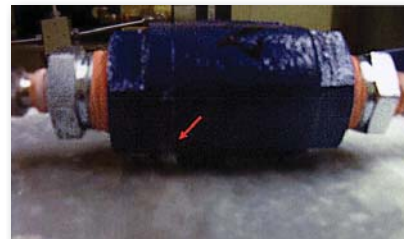
Figure 3A: Failure mode of Sample# 13-06-C0161-2, Body fractured at 6,613 psi.

Sample #	Burst Pressure (psi)	Comments
13-06-C0161-1	6,753	Body fractured.
13-06-C0161-2	6,613	Body fractured.
